HISTORIC STRUCTURES REPORT
PART I
ARCHITECTURAL DATA SECTION
ON
THE PAW PAW TUNNEL
C & O Canal National Monument

Prepared by
Archie W. Franzen
Architect
March 1965

United States Department of the Interior, National; Park Service
Eastern Office, Design and Construction
Division of Architecture

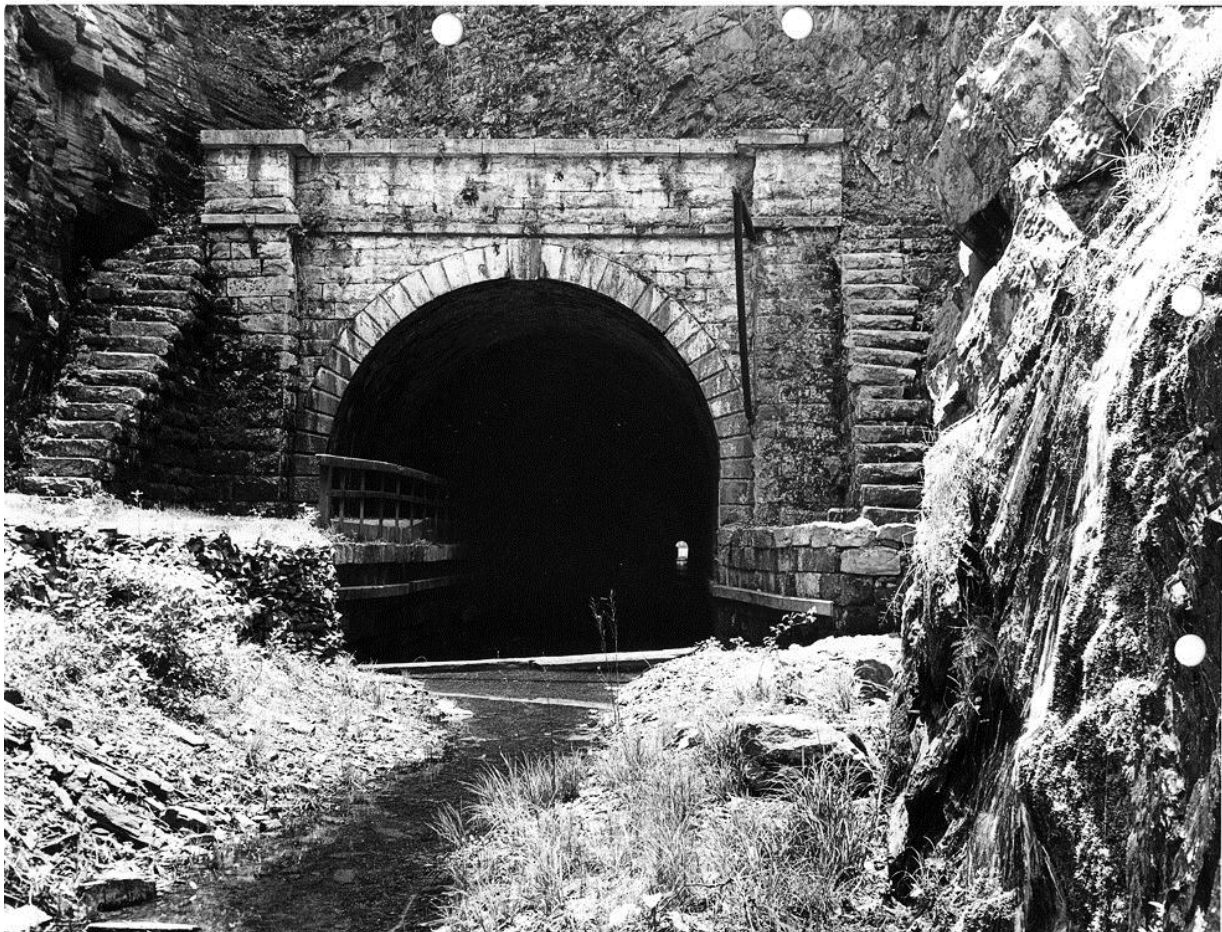
ILLUSTRATION NO 1
PHOTOGRAPH OF NORTH PORTAL

The portals are constructed similarly and are of equal size. They are twenty-four feet wide. The boom seen at the rebate of the pilaster on the right was used to slip timber gate sections into slots located in the masonry below the towpath level on each side and 2' - 2" forward of the face of the portal. The gates when not in use were stored on the platform on the right on the raised stones as shown in the photograph.

As can be seen, the stepped flanking walls at each side require attention. The top of stepped stones are loose and should be reset. The inscription stone above the keystone can barely be made out and is inscribed J. M. Coale, President, 1850. The keystone of the south portal is inscribed C. B. Fisk, Engineer.

Stones of both masonry portals that have been forced out of alignment should be reset and missing capstones should be replaced. The grade at the top of the portals between the face of the portals and the embankment behind them is level with the capstones of the cornices. At present drainage from the embankment works its way behind the masonry, and from frost action tends to move the capstones out of line. This water should be collected in drain pipes and disposed of off to one side. The top layers of stone masonry of the stepped flanking walls need resetting, and if possible, a sloping drain channel along the side next to the embankment should be worked in to carry the runoff away. The stone joints of the portal masonry should be repointed.

The masonry joints of both portals should be repointed as well as the twenty-six feet long stone masonry returns of the vault and sidewalls within the tunnel.

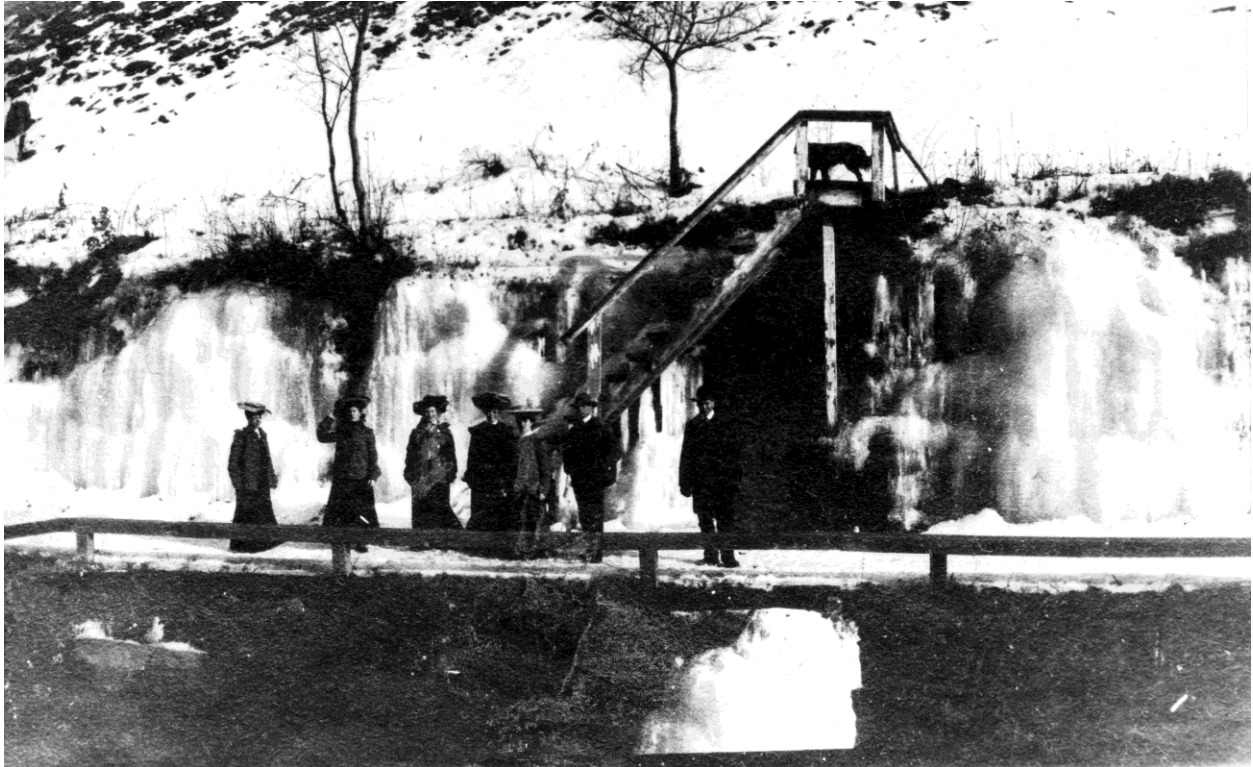
ILLUSTRATION NO 2 VIEW OF SPRING NORTH OF TUNNEL

The spring is located at the head of the steps. While it has been called a spring, it is not known for sure if it has a subterranean origin or if it is runoff water finding its way to this point from the ravine above. The effect of the water if it is not collected and channeled can be seen in this view, taken around 1910 as indicated by the style of the clothes worn by the people in the foreground. The stairs shown have probably been rebuilt many times over the years.

The mouth of the spring at the northern terminus of the wood towpath should be rehabilitated and provisions made to adequately conduct its flow under the towpath to avoid flooding the surface of the deck. A flight of wooden steps gave access to the spring from the towpath platform below. The photograph in the Appendix shows the direction of the stairs, with twelve risers leading up to the platform at the head of the flight. The platform was supported from below by a slanting timber. The steps were at least two inches thick with open risers, and were supported on three carriages. A single rail served as a guard.

Wells have been drilled near the tunnel making safe drinking water available to the visitor. As a consequence, it would appear advisable to omit reconstructing the wood stairs to the spring so visitors would not be tempted to try the water from the spring.

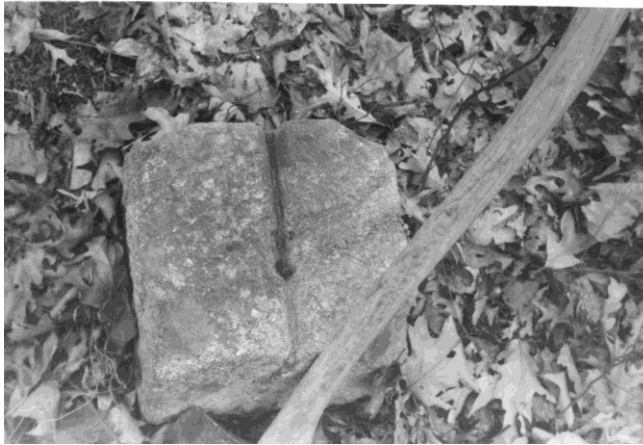
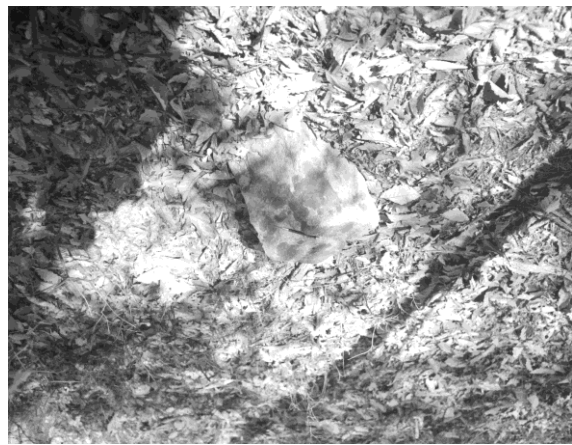
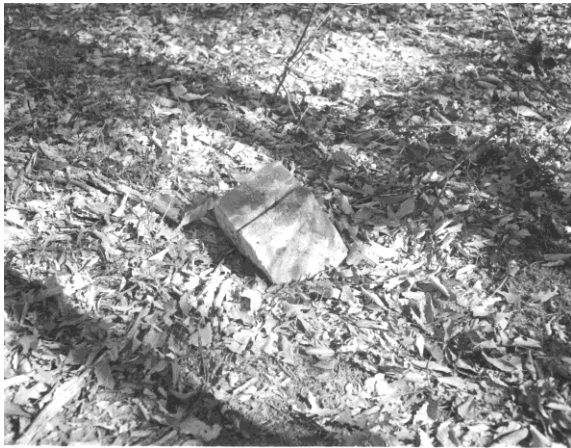
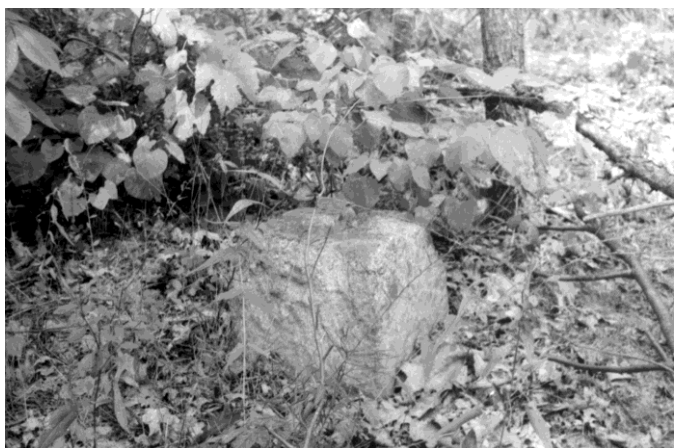
ILLUSTRATION NO 3
STONE ALIGNMENT MARKERS

There were six of these stones, five of which have been found and are located at high points of the ridge above the tunnel. They fall on a line above the bore of the tunnel. They were used to check the alignment of the work as it progressed and to determine the amount of work accomplished so that pay estimates could be made up.

The stone markers are approximately ten inches square on top, increasing to about fourteen inches at their base, and are around four feet long. About six to ten inches of their height is exposed above the ground. Each has a groove on top running perpendicular to the line of the tunnel and in the groove a small hole is drilled, probably to mark the center line of the bore. They do not appear to be local stone as they are reddish and have a quartz like texture.

One of the centering stones on top of the hill above the tunnel has been somewhat shifted by vandals in an apparent effort to remove it. The stone should be realigned and firmly reset.

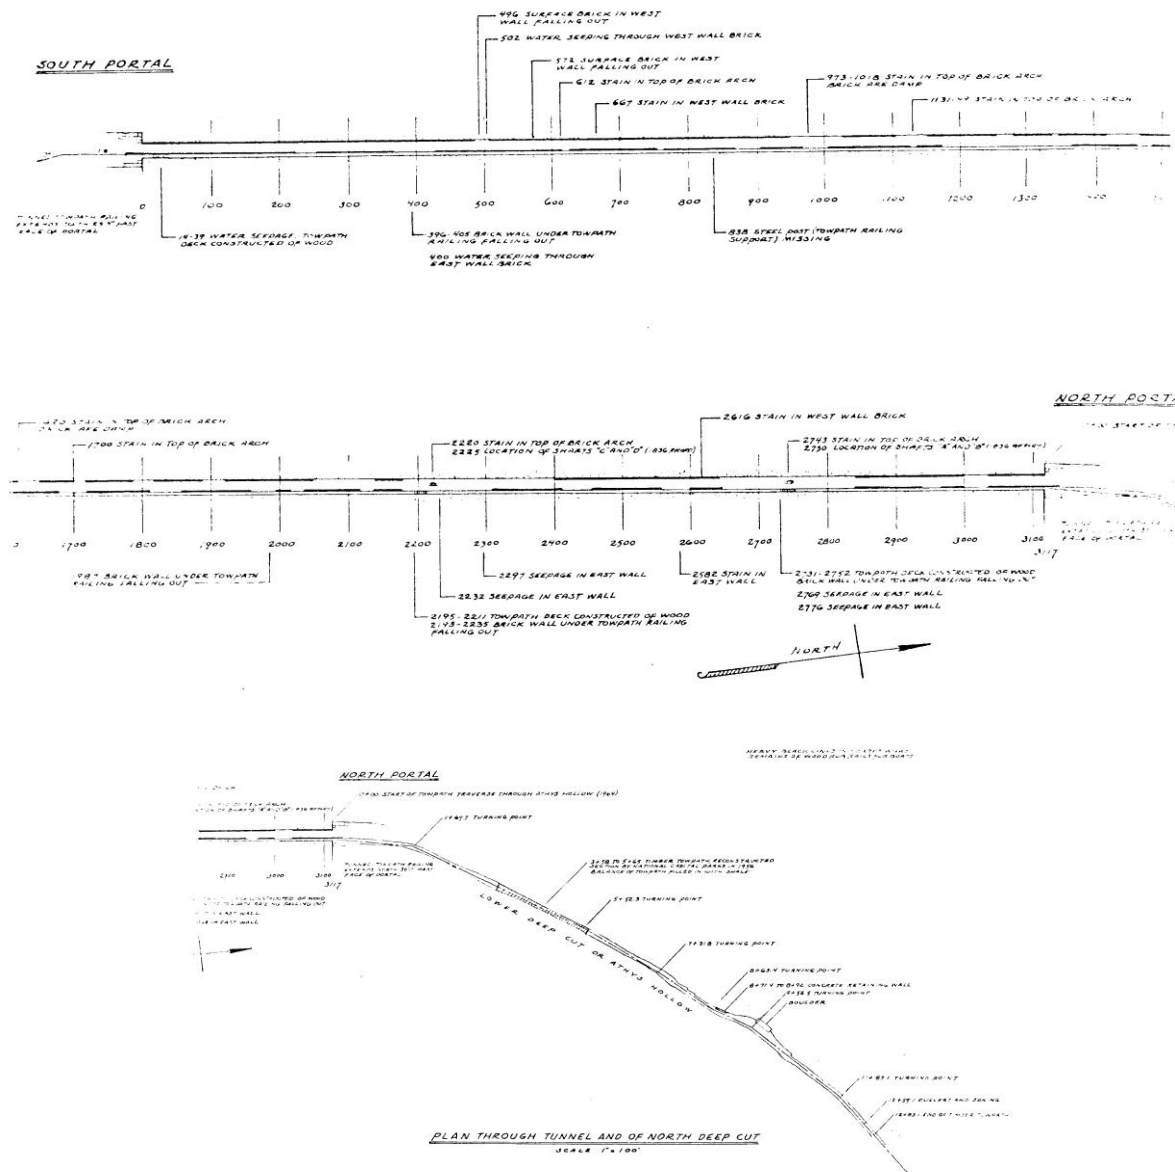
SKETCH NO. 1

This plan shows the data collected with the aid of summer student assistants. The heavy black lines within the tunnel show how much of the rub or boat rails remain at present. Various notes call attention to the more noticeable areas where water or dampness is permeating the brick vault lining. The distances given were measured at the site.

A traverse through the "deep cut" and beyond is delineated and shows the amount of timber tow-path reconstructed by National Capital Parks. The spring mentioned in the report is shown as well as the point where a massive boulder has fallen into the canal bed.

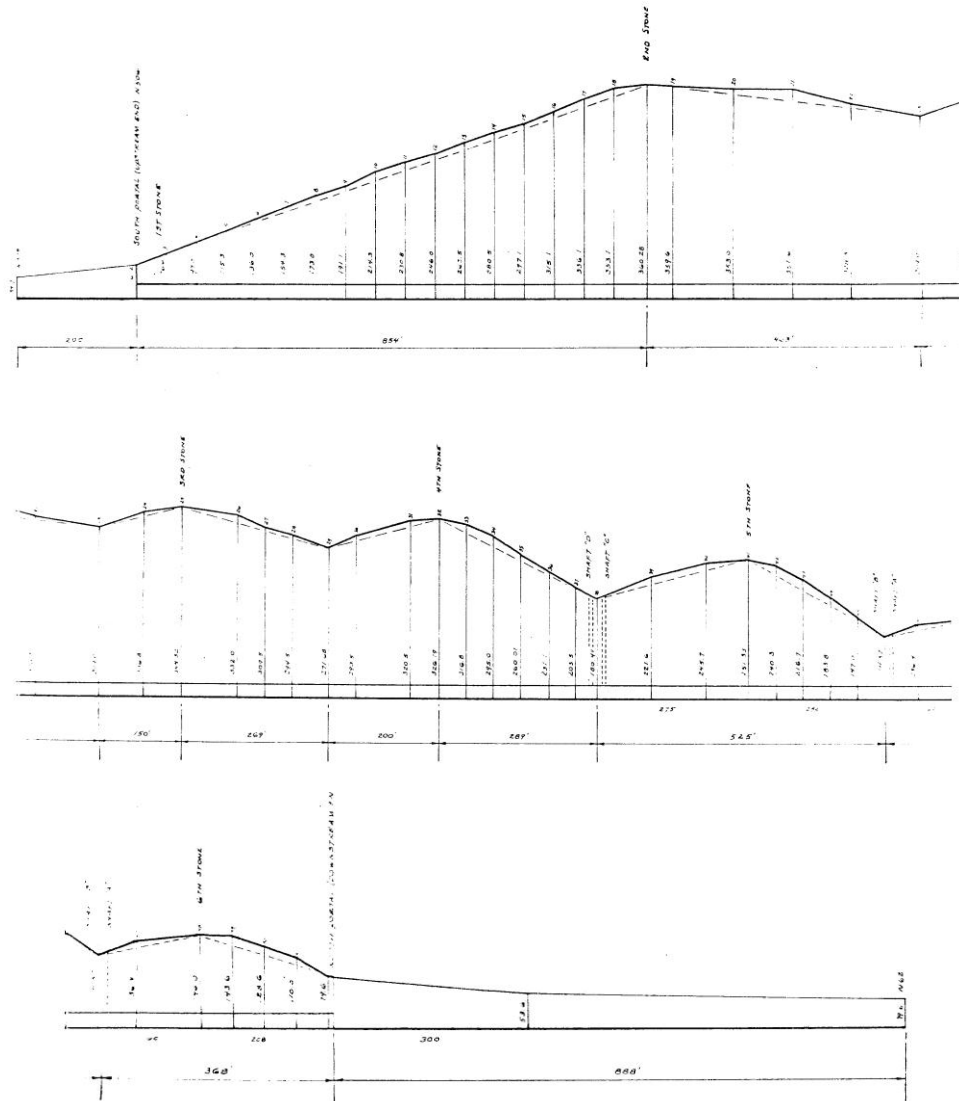
SKETCH NO 2 PROFILE THROUGH TUNNEL AND APPROACH CUTS

This drawing is adapted from a Canal Company drawing dated December 1, 1836. The shafts are noted in the two northernmost ravines. The alignment stones were located on the ridges over the bore and their locations from the ends of the tunnel are given. The stone labeled "third stone" has been shifted and should be reset correctly. The stone labeled "first stone" has not been recovered. It may have stolen.

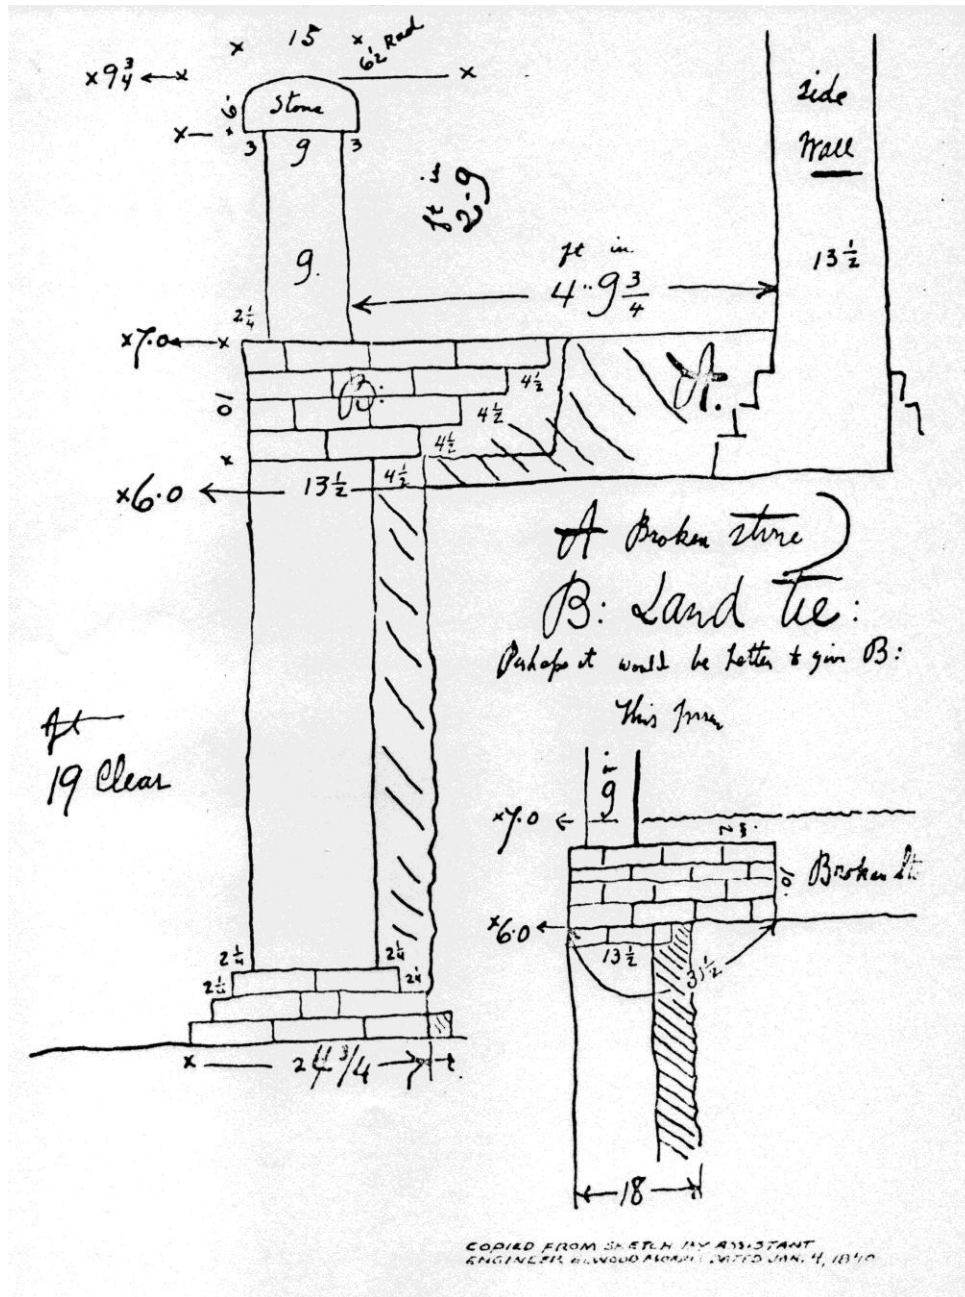
SKETCH NO 3
COPY OF EARLY PROPOSAL FOR CONSTRUCTING
THE TOWPATH WITHIN THE TUNNEL

This sectional sketch would indicate that a shelf was left in the bore for the tunnel towpath. However, this has not been ascertained. The brick and stone railing was not built. Instead a wood railing supported on wrought-iron posts secured to wooden cross members was used. This is more fortunate in that a brick parapet type wall of only nine inches in thickness could scarcely have withstood the combination of moisture within the tunnel and the strain of the tow ropes.

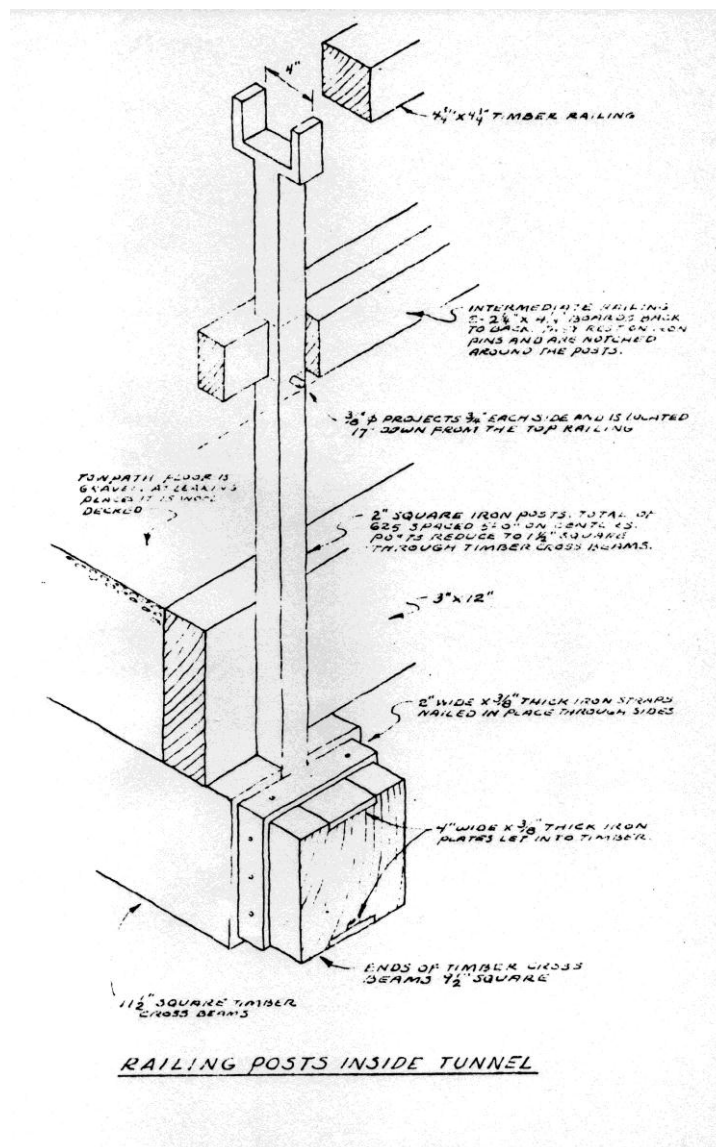
SKETCH NO 4 DETAIL OF TOWPATH RAILING WITHIN THE TUNNEL

The railing now in use is pictured in this sketch. The uprights are two inch square iron posts wrought to form a fork at the top to receive the four inch square wood railing. An intermediate railing was made of two pieces and notched around the posts. They were kept from sliding down the posts by 3/8" round pins driven through the posts so that the bottom of the rail rested on the pin.

The posts were secured to eleven and a half inch square cross timbers reduced to nine and a half inches square at their ends. The portion of the iron posts passing through the timber was reduced to one and a half inches square and also passed through 4" x 3/8" iron plates which were let into the top and bottom faces of the timber. The plates acted somewhat like washers and the whole assembly was further secured in place by 2" x 3/8" iron straps nailed to the timber.

The steel posts of the towpath guard rail (625 in all) are mainly in good condition. There is one post missing, 838 feet in from the south portal, and a few of the posts in the vicinity of the shafts are heavily corroded. These should be replaced and the remaining posts cleaned of rust and painted. The steel straps securing the posts to the cross timbers should be removed, cleaned, painted and refastened. Where they are too corroded, they should be replaced for safety reasons.

As much of the 4" x 4" top rail as possible should be saved to retain the chafe marks of the tow ropes. The intermediate railing will require some refurbishing and replacement.

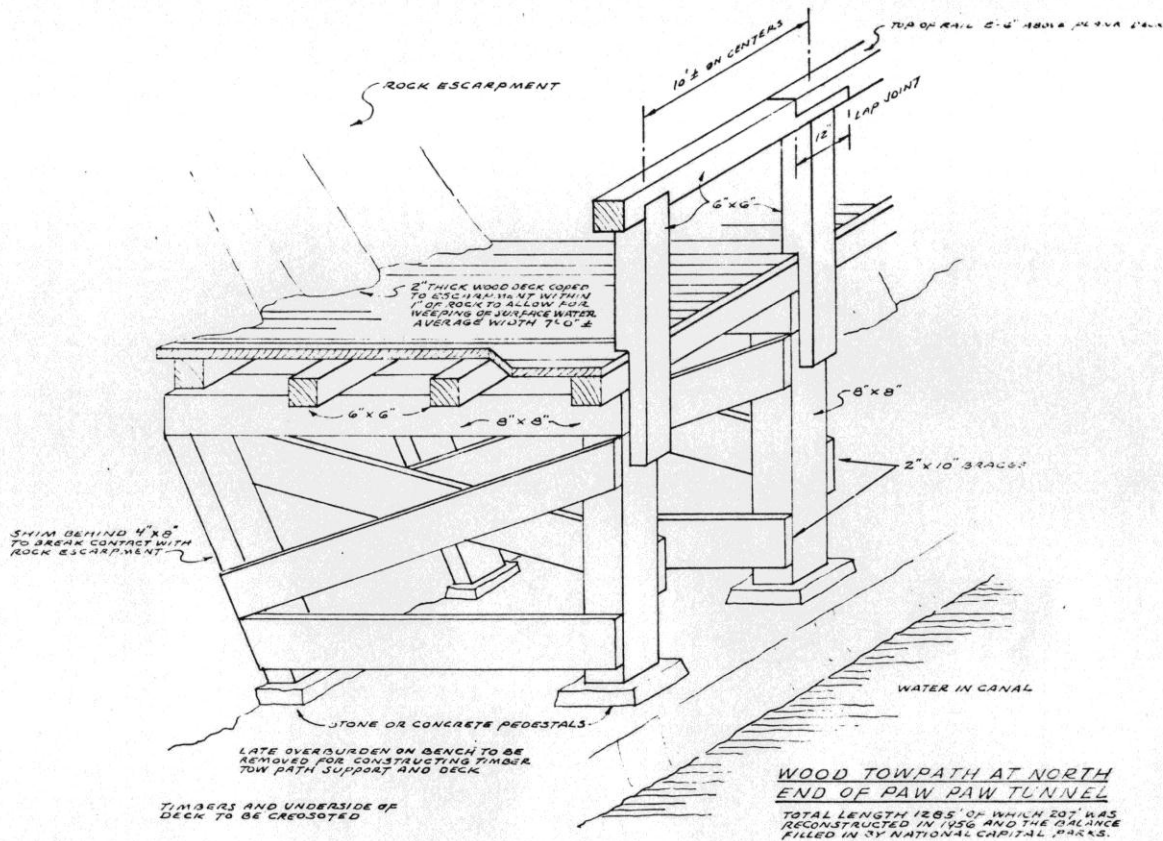
SKETCH NO 5 TOWPATH CONSTRUCTION NORTH OF TUNNEL

The railing outside of the tunnel is lower than the railing within. Timber construction was more likely adopted because of the sloping embankment and the difficulty of establishing a uniform bearing for a retaining wall that would have been necessary to hold solid material in place. The canal bed is relatively narrow within the "deep cut", and as a result space was at a premium. This type construction also permits surface water from the steep and laminated embankment to drain under the towpath and into the canal.

The timber supported towpath through the "deep cut" north of the tunnel will have to be reconstructed. It would stop at a point 1285 feet north of the north portal. Two hundred lineal feet within this distance has been previously reconstructed by the National Capital Parks, and the 25 feet immediately adjacent to the tunnel is of masonry construction, leaving approximately 1065 feet of towpath to be rebuilt.

A sketch in the Appendix illustrates the construction of the towpath which requires reconstruction. The decking consists of two inch planks running normal to the direction of the path. The planks are butt jointed along their length and coped as they meet the slope and protrusions of the embankment along its east side. Because of the irregular horizontal profile of the embankment,

The planking is supported by longitudinal timbers 6" x 6" in size and spaced about thirty inches apart. These in turn are carried on cross timbers 8" x 8" in size and spaced ten feet on centers along the length of the towpath.

The west end of the cross timbers have an 8" x 8" vertical post for support and their eastern ends are supported on 4" x 8" timbers laid at a slant conforming to the slope of the rock embankment. The posts are cross braced apart with 2" x 10" planks. A six inch square wood guard rail is supported thirty inches above the deck with six inch square posts located at the ends of the 8" x 8" transverse timbers. The guard rail is half lapped over its supporting posts. All of the timber construction, except for the railing, the railing posts and the walking surface of the deck should be creosoted.

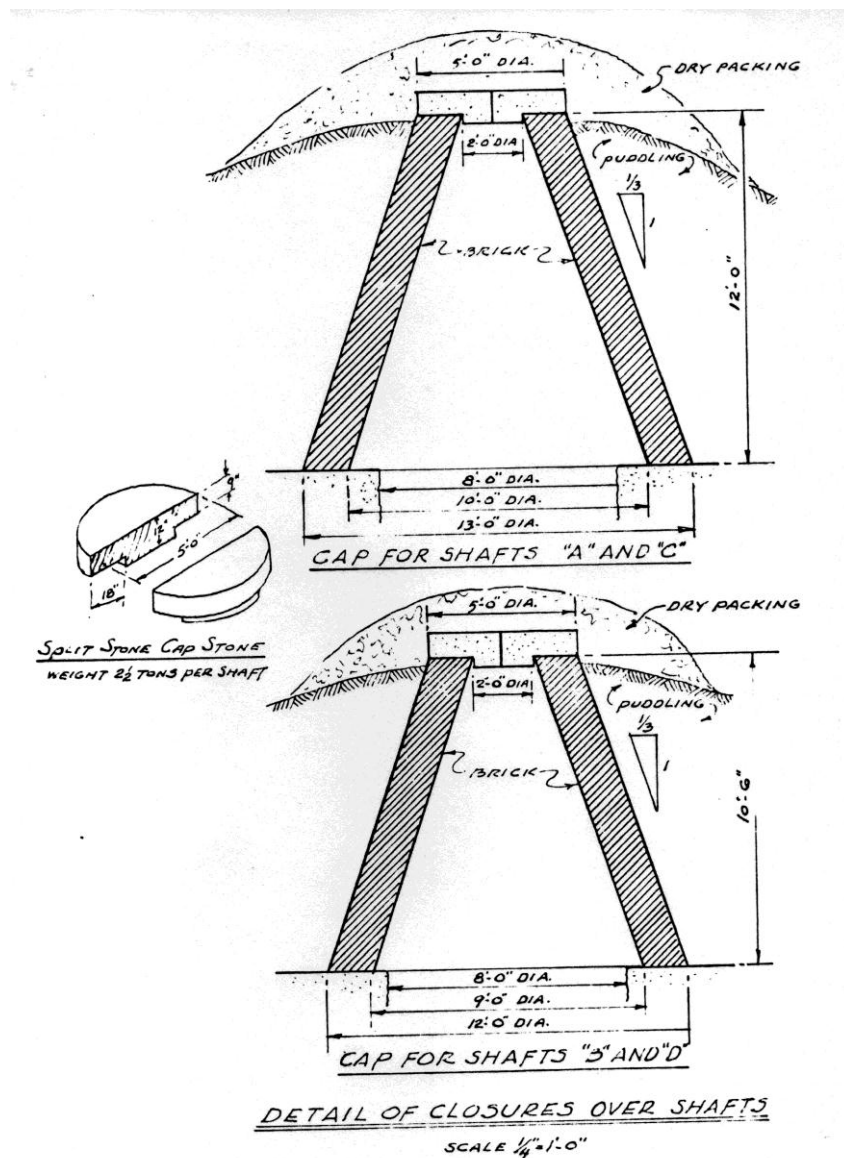
SKETCH NO 6
SKETCH INDICATING METHOD OF CAPPING
THE TUNNEL SHAFTS

Filling the shafts with loose material would have imposed a very considerable load on the tunnel's brick lining. This probably explains why the shafts were left open and capped following the completion of construction. The conical brick caps were founded on natural rock and brought up to final grade and to a diameter convenient for bridging with a cover. The stone covers were made in halves because of their weight, allowing them to be placed or removed as necessary. The backfill around the brick was puddled to form an impervious protection and the whole covered with stone termed "dry packing" in the Canal Company records.
